STUDY OF CONVENTIONAL TILE FIELDS IN FINE - GRAINED SOILS

REPORT NO. 74

December 1978

Applied Sciences Section
Pollution Control Branch
Ontario Ministry of the Environment

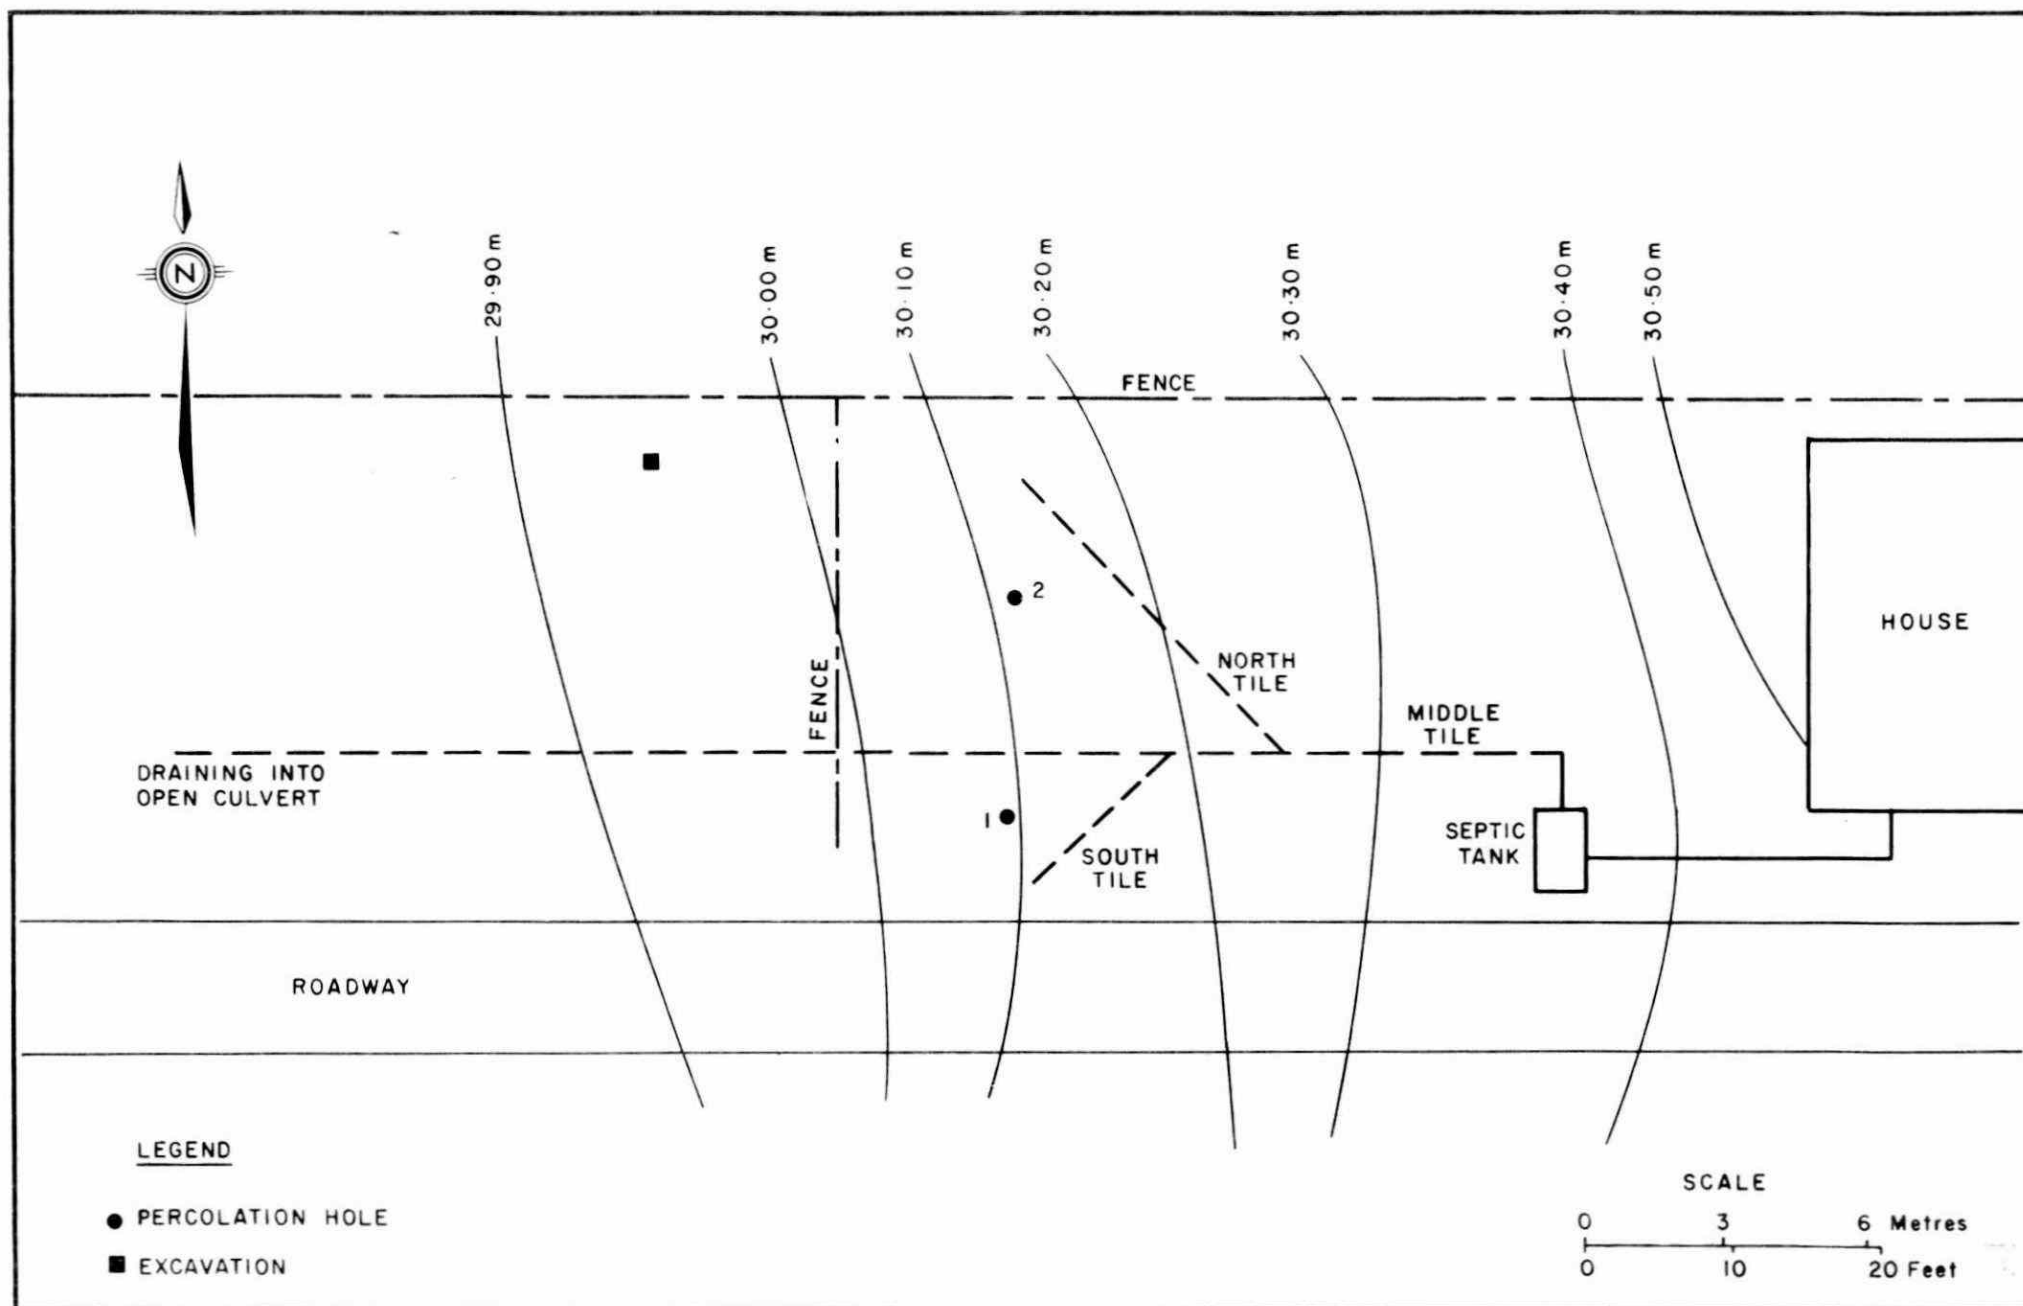
FIGURE 15: LAYOUT, TOPOGRAPHY AND LOCATIONS OF PERCOLATION HOLES AT SITE M2.

part of the tile field did not seem to work properly and the system backed up occasionally. To alleviate the problem the owner extended the middle tile 13 m and exposed the end of the tile in a dug trench, leading into a road culvert. The tiles were located at shallow depths and the maximum depth was about 40 cm with the end of the middle tile being exposed to the ground surface (See Figure 16).

On the basis of the tensiometer readings and field observations, it was concluded that the tile field was not operating in a satisfactory condition. In order to explain the performance of the tile field, it is necessary to examine the profile of the three rows of tiles (Figure 16). The middle tile sloped down from the exit of the septic tank and then sloped upward and downward again. Also, the north tile had the steepest slope. Because of this arrangement and construction of the three rows of tiles, a larger portion of the septic tank effluent would likely be distributed into the north tile.

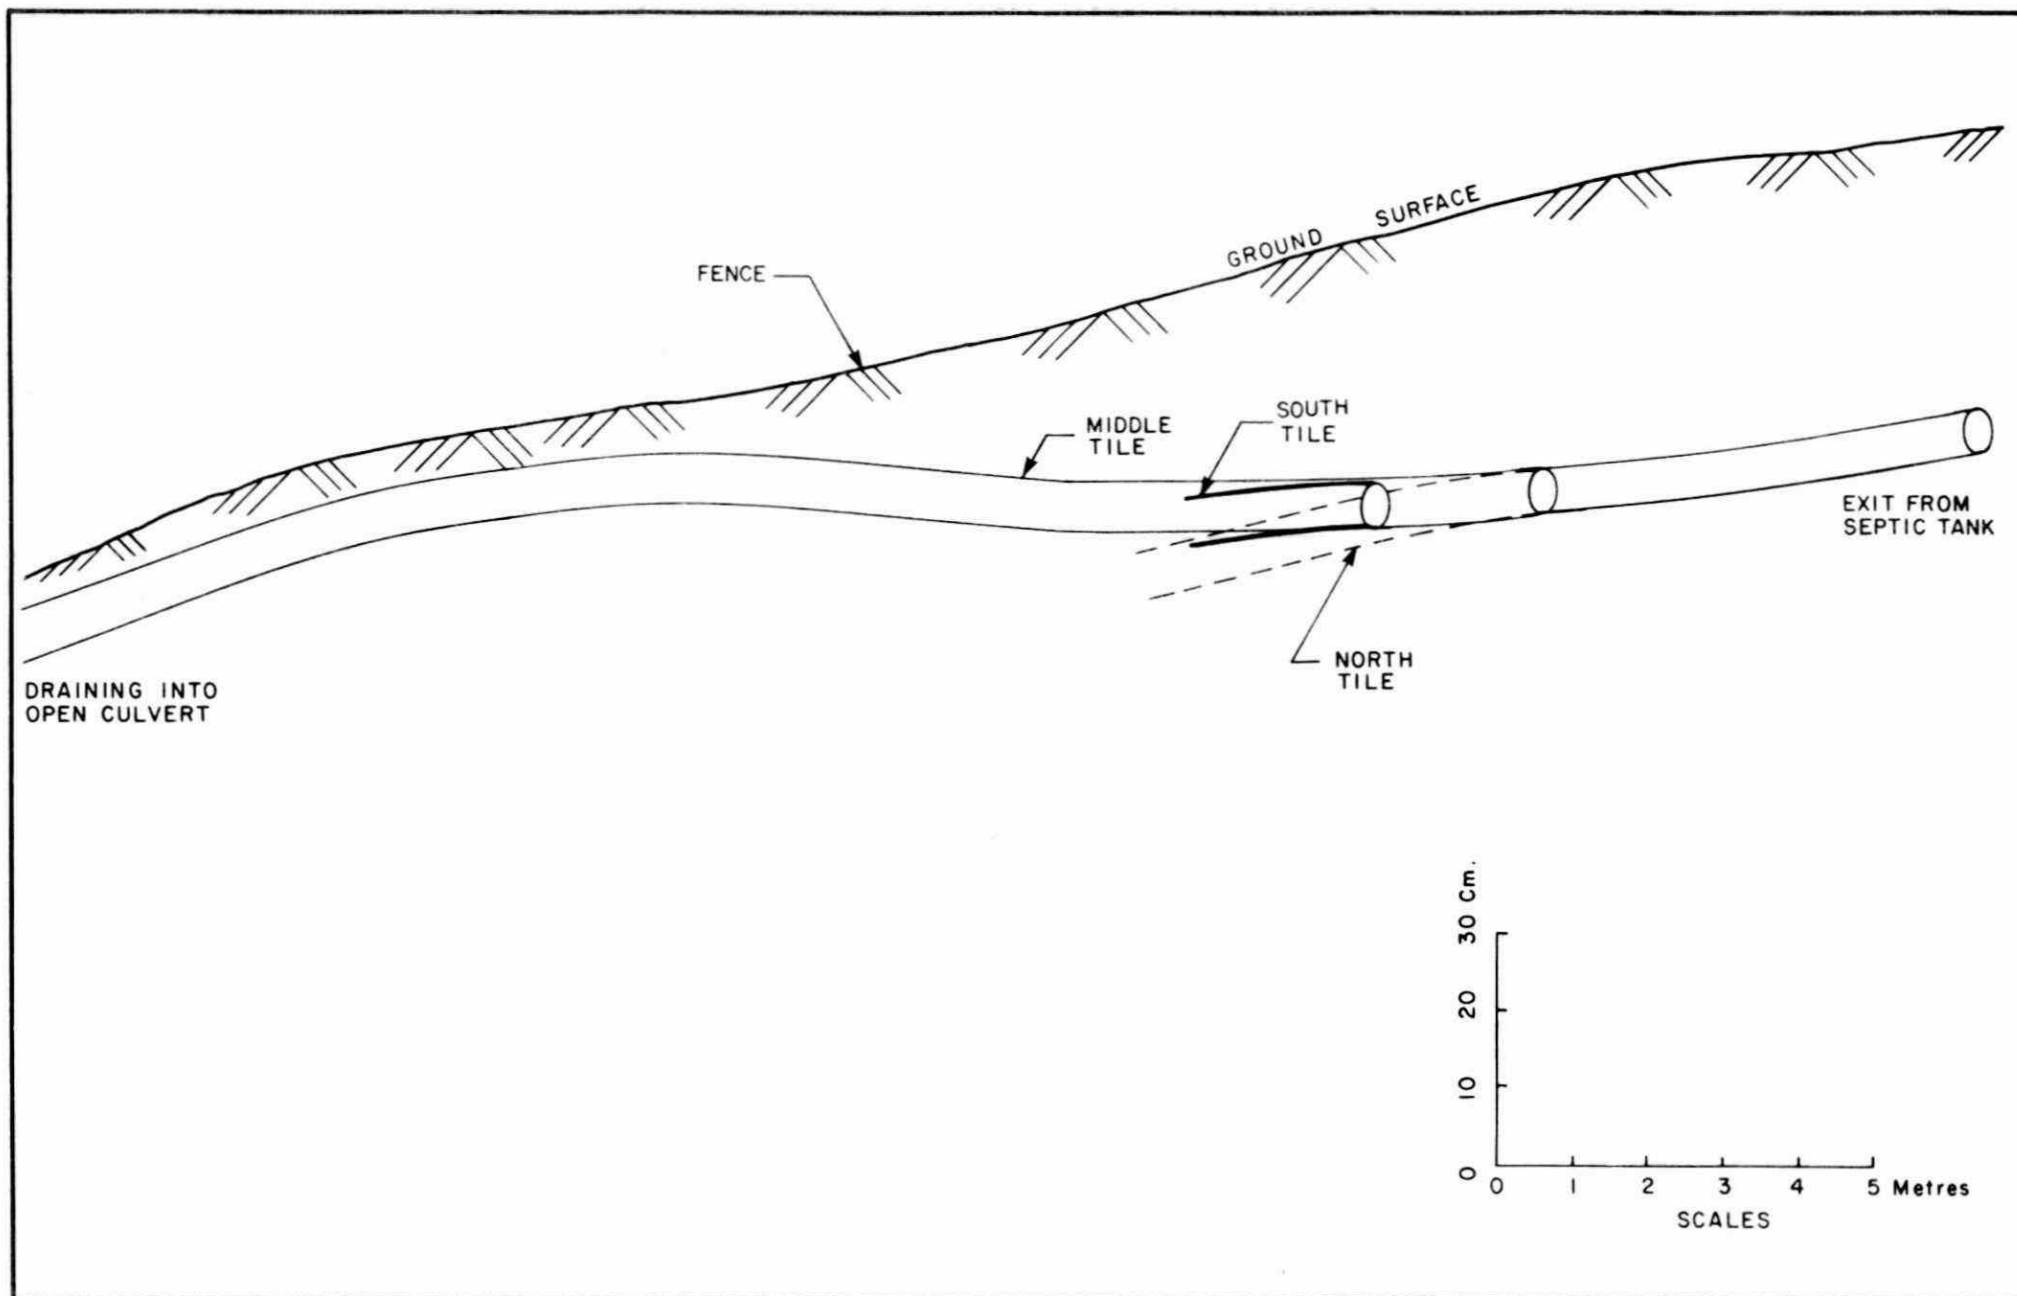
FIGURE 16: PROFILE OF TILES AT SITE M2.

Furthermore, it would be virtually impossible, under the gravity flow condition, for the septic tank effluent in the middle tile to reach the open culvert. In fact, the varying slopes of the middle tile would make the portion of tile closer to the road useless. If the total useful length of the three rows of tiles was used for the calculation of the hydraulic loading rate on the tile field, the average value would be equal to $33.4 \text{ L/m}^2/\text{d}$ ($0.67 \text{ gals./ft.}^2/\text{day}$) for the case of uniform distribution of effluent in the tiles. Under the actual condition, the distribution of flow was not uniform; and, therefore, the loading rate on the north tile would be greater than the average value. Referring to the percolation test results in Table 5, the percolation time of the soil in the tile field area was about 80 min./cm (200 min./in.), suggesting poor drainage characteristics of the soil. However, the laboratory hydraulic conductivity of the soil was in the order of 10^{-4} cm/s , which would indicate a soil of medium permeability. These apparent conflicting results may be explained by the non-uniform soil conditions at the site. Because the excavation was made in the area quite far away from the tile field, the percolation test results which were performed between the rows of tiles may be a better indication of the drainage characteristics of the soil in which the tile field was constructed.
